Thermal Infrared Survey of Hazardous Waste Sites East St. Louis, Illinois

prepared for
EPA Region 5

THERMAL INFRARED SURVEY OF
HAZARDOUS WASTE SITES
EAST ST. LOUIS, ILLINOIS

D. L. Becker
Environmental Programs
Lockheed Engineering and Management Services Company, Inc.
Las Vegas, Nevada 89114

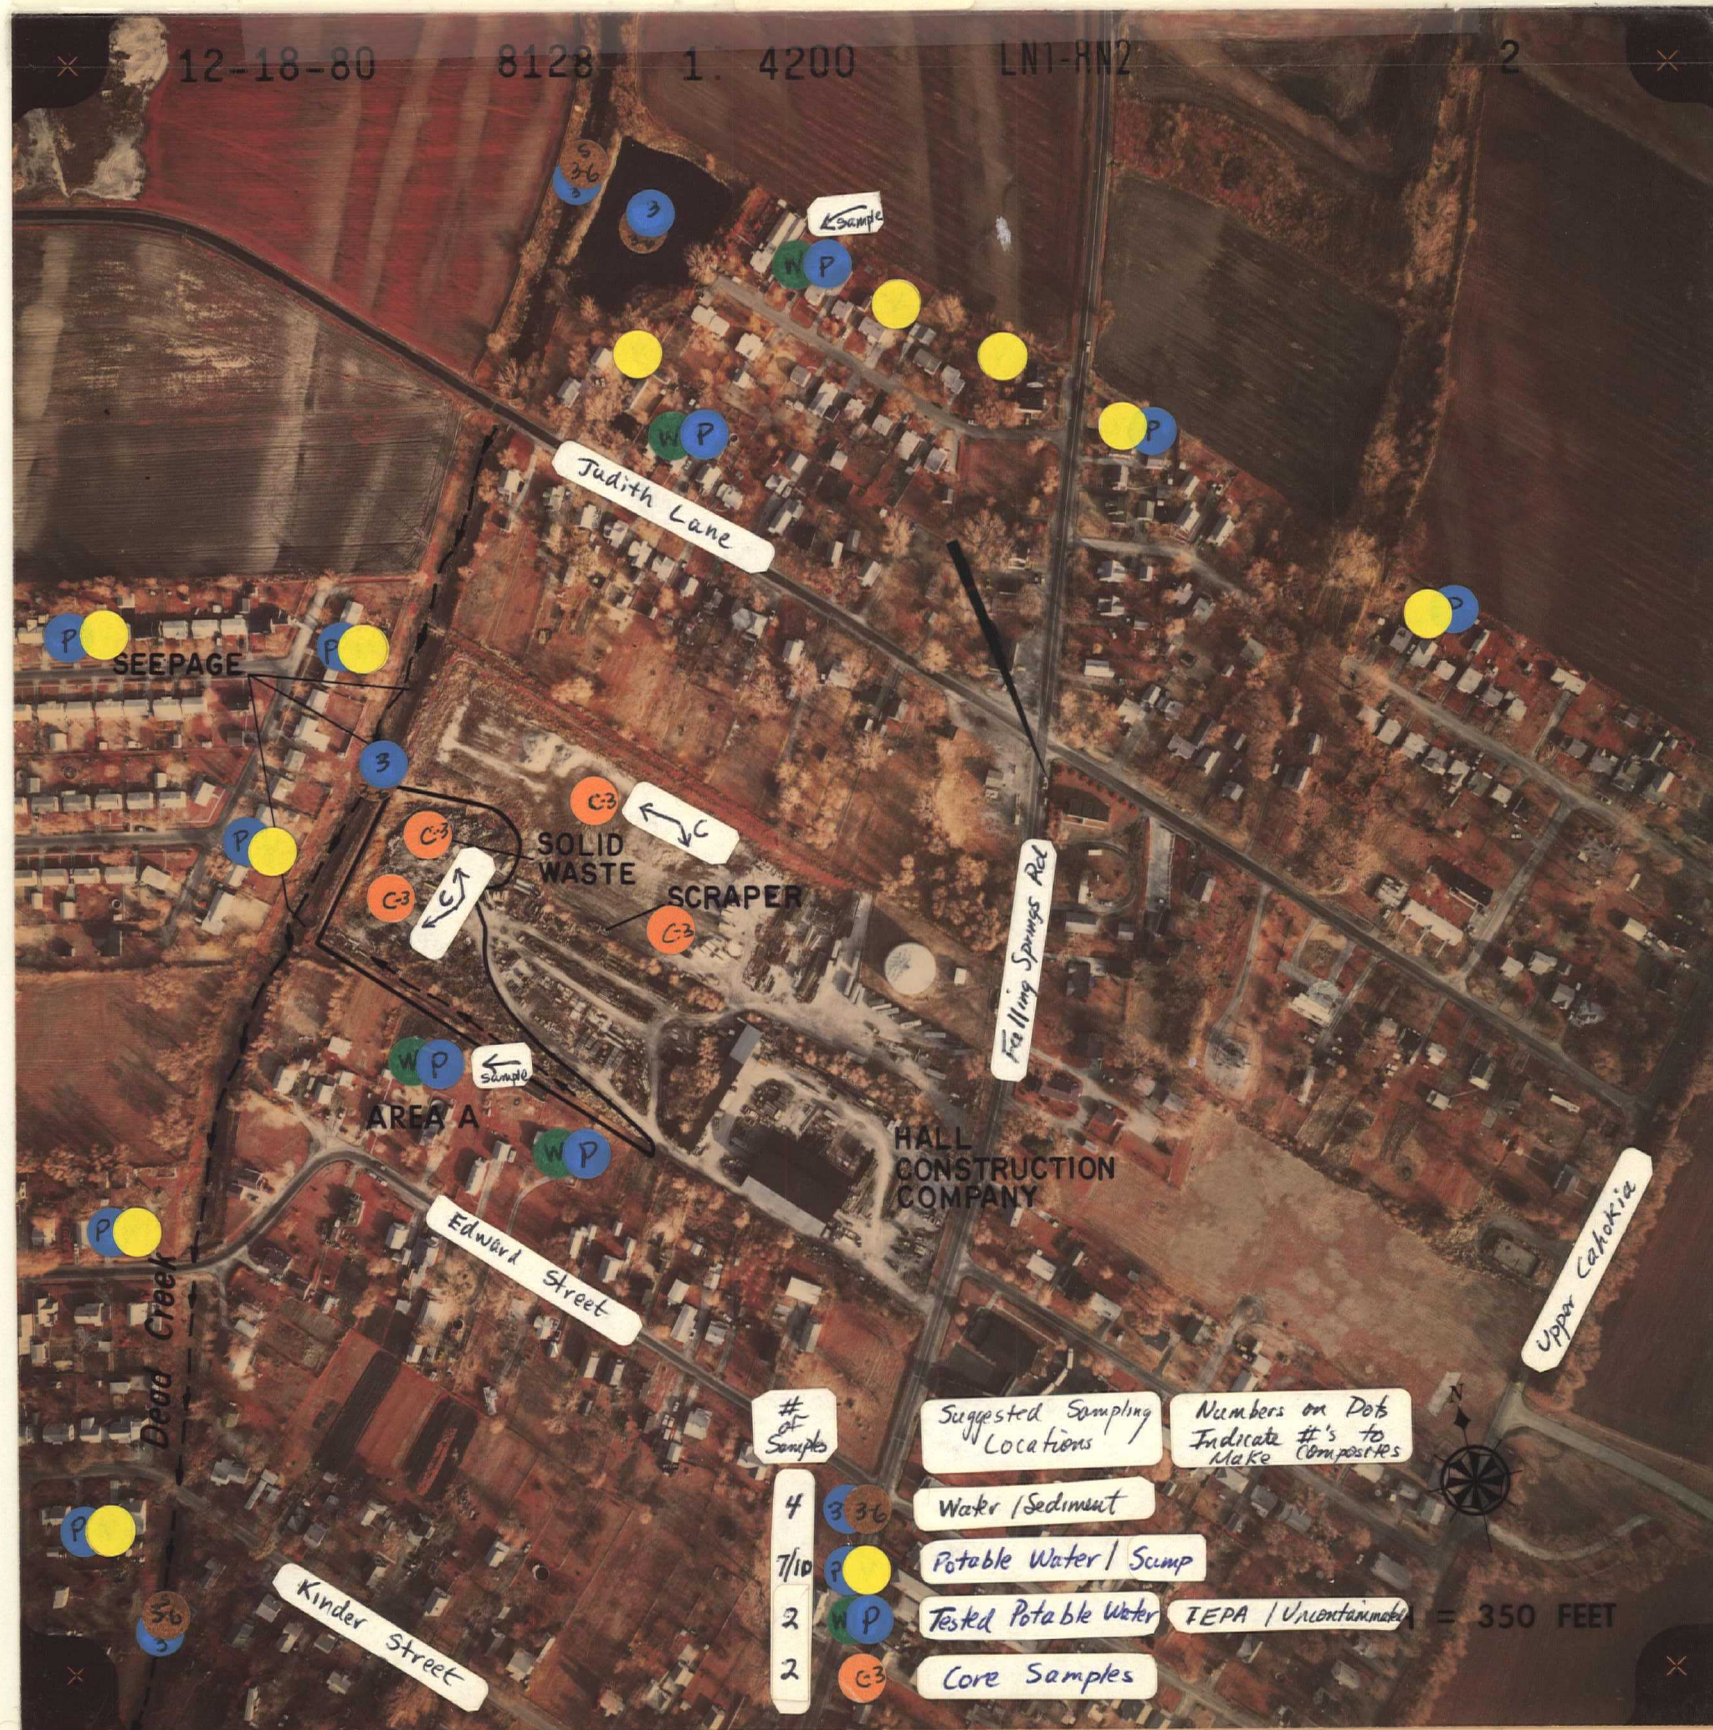
CAHOKIA

Area "A" is an industrial waste site associated with Hall Construction Company, adjacent to Dead Creek. The waste pit is revetted along the creek; however, seepage stains are noted through the pit revetment as well as the adjacent, abandoned quarry. All spills/runoff from the entire site will collect along the Dead Creek revetments. Recent scraper operation is visible in the abandoned quarry; however, the content of the fill material can not be determined from aerial photography.

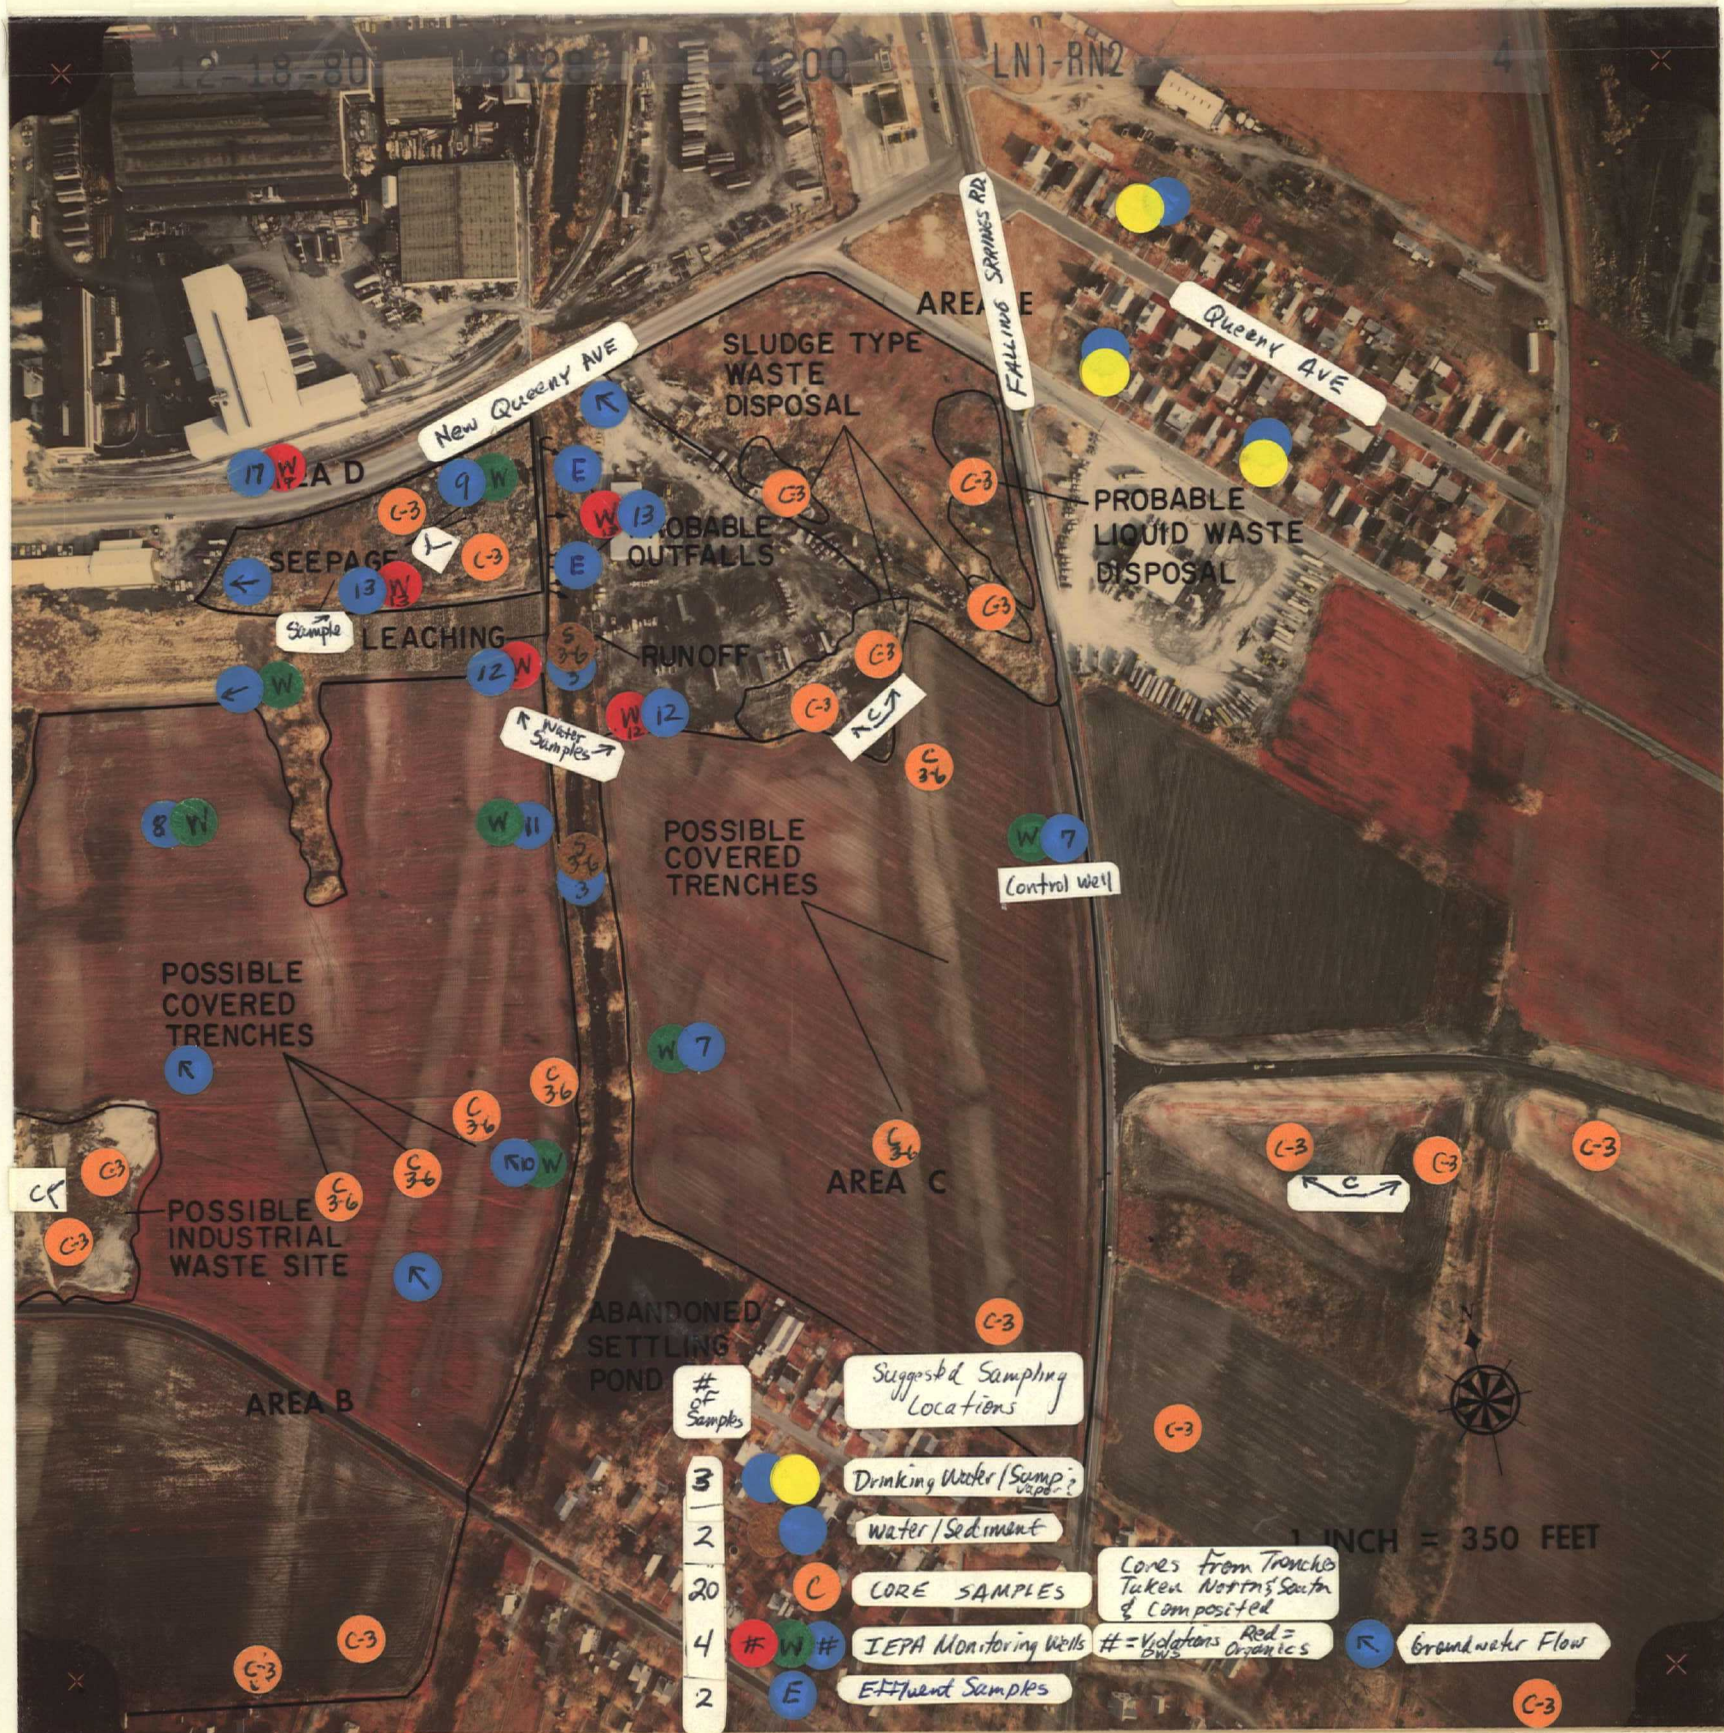
SOUTH
SAUGE T

Area "B" and "C" are potential revegetated waste disposal areas. Both areas display vegetation damage patterns of subsurface influence. The distinct edges of the stress patterns indicate a trench effect as opposed to the more mottled patterns in the same areas which could be caused by naturally poorer soil. It is recommended that archival photography be acquired of Areas "B" and "C" to ascertain the definite cause of these stress areas and, possibly, the origin of the stress causing materials. Heavy vegetation along the banks of the Dead Creek preclude detection of possible leaching into the creek from either of these two areas. Extensive dozer activity within the small annotated area, located in the southwest corner of Area "B", indicates possible industrial waste disposal. Incomplete stereo photographic coverage precludes positive identification as a waste site.

Area "D" appears to be an old disposal area with heavy overgrowth. Surface seepage is apparent within the site and evidence of leaching is visible along the west bank of Dead Creek.

Area "E" has extensive sludge-type waste being disposed of in the central and southeast portions of the site. Extensive stains and the presence of two truck tanker trailers indicate the eastern portion of the area is being used for liquid waste disposal. No surface seepage is visible; however, some runoff from the southwest has been entering the Dead Creek. Also, two drains, probably originating in the large building on the site, are visible on the east bank of the creek.

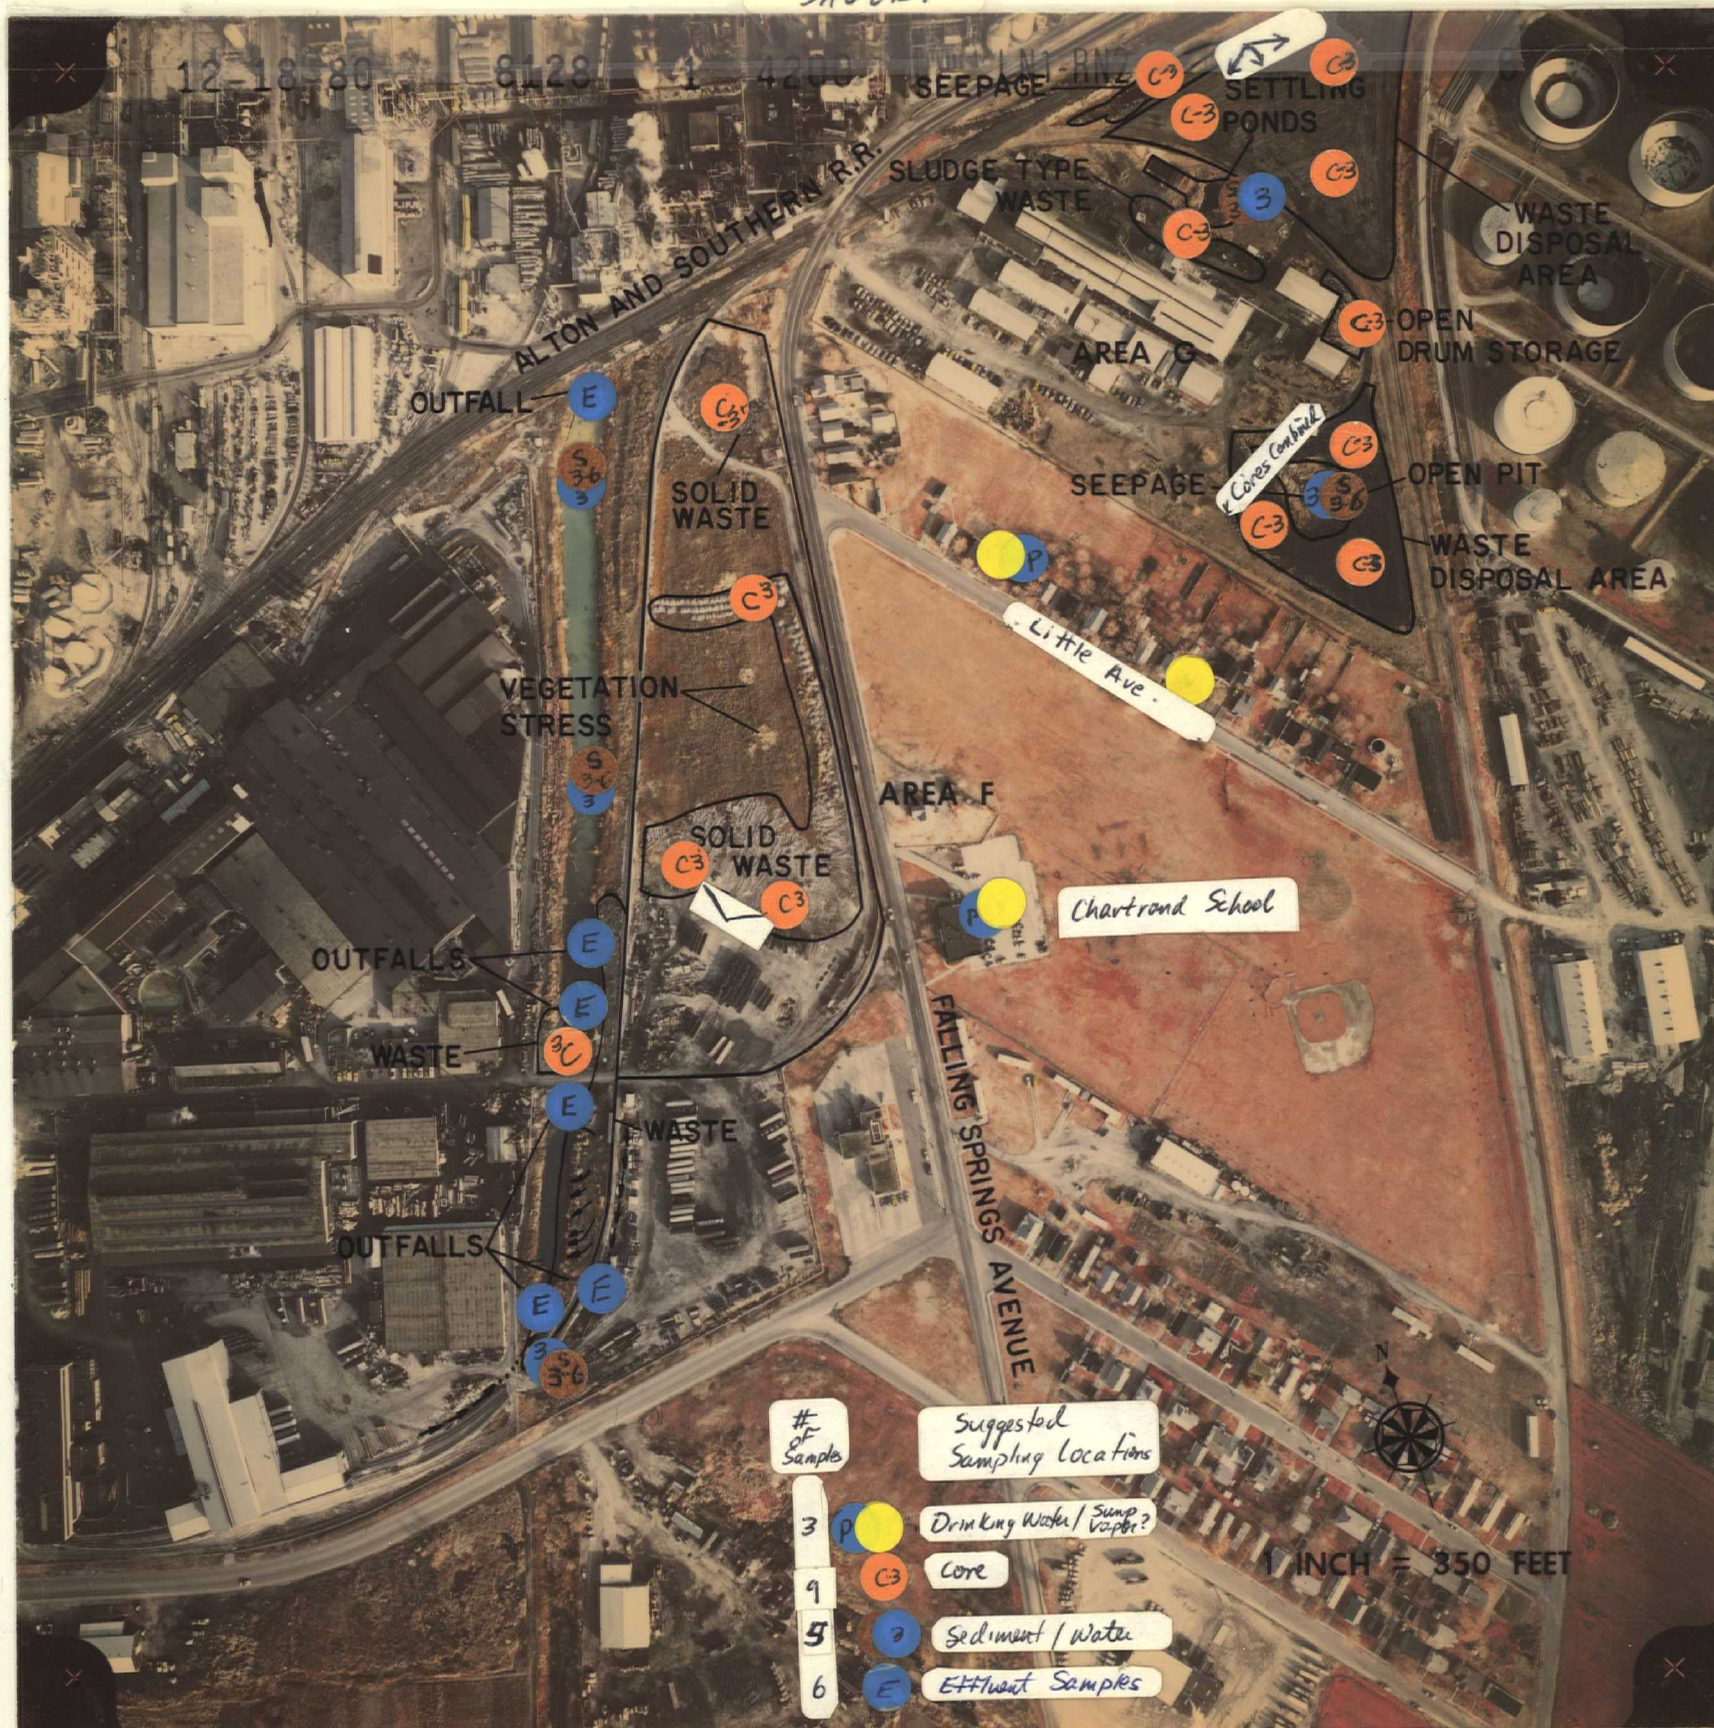
NORTH SAUGET

Area "F" is a solid waste disposal site immediately west of Chartrand School. Sludge-type waste is being dumped throughout the area. The area between the railroad tracks and the Dead Creek lagoon appears to be used for railroad car cleaning. Surface drainage from this area enters directly into the lagoon. Drainage from the truck park area parallels the western perimeter and enters the lagoon via a culvert under the railroad tracks. The main plant to the west has three visible outfalls and one surface drainage into the lagoon. The lagoon does not extend beyond the road forming the southern perimeter of the main plant and culminates at a culvert under the Alton and Southern Railroad to the north. [No effluent is visible either entering or exiting the culvert at the time of overflight; however, due to the flat terrain, liquids could flow in either direction, depending on amount and location of discharge.]

Area "G" is located just east of the intersection of Falling Springs Avenue and the Alton and Southern rail line. There are two waste disposal areas within the small industrial complex. The area in the southeast corner of the site surrounds a large open pit containing an accumulation of seepage at its apex. Containerized waste is visible within the pit; however, the surrounding area appears to consist of graded sludge. The visible waste in the northern disposal area consists entirely of graded sludge. A crane is in the process of removing sludge from the settling ponds immediately north of the plant. Approximately 800 drums are stacked in an uncontained area adjacent to the westernmost plant building. Surface seepage is visible along the perimeter of the northern disposal area; however, it appears to be contained by the railroad junction.

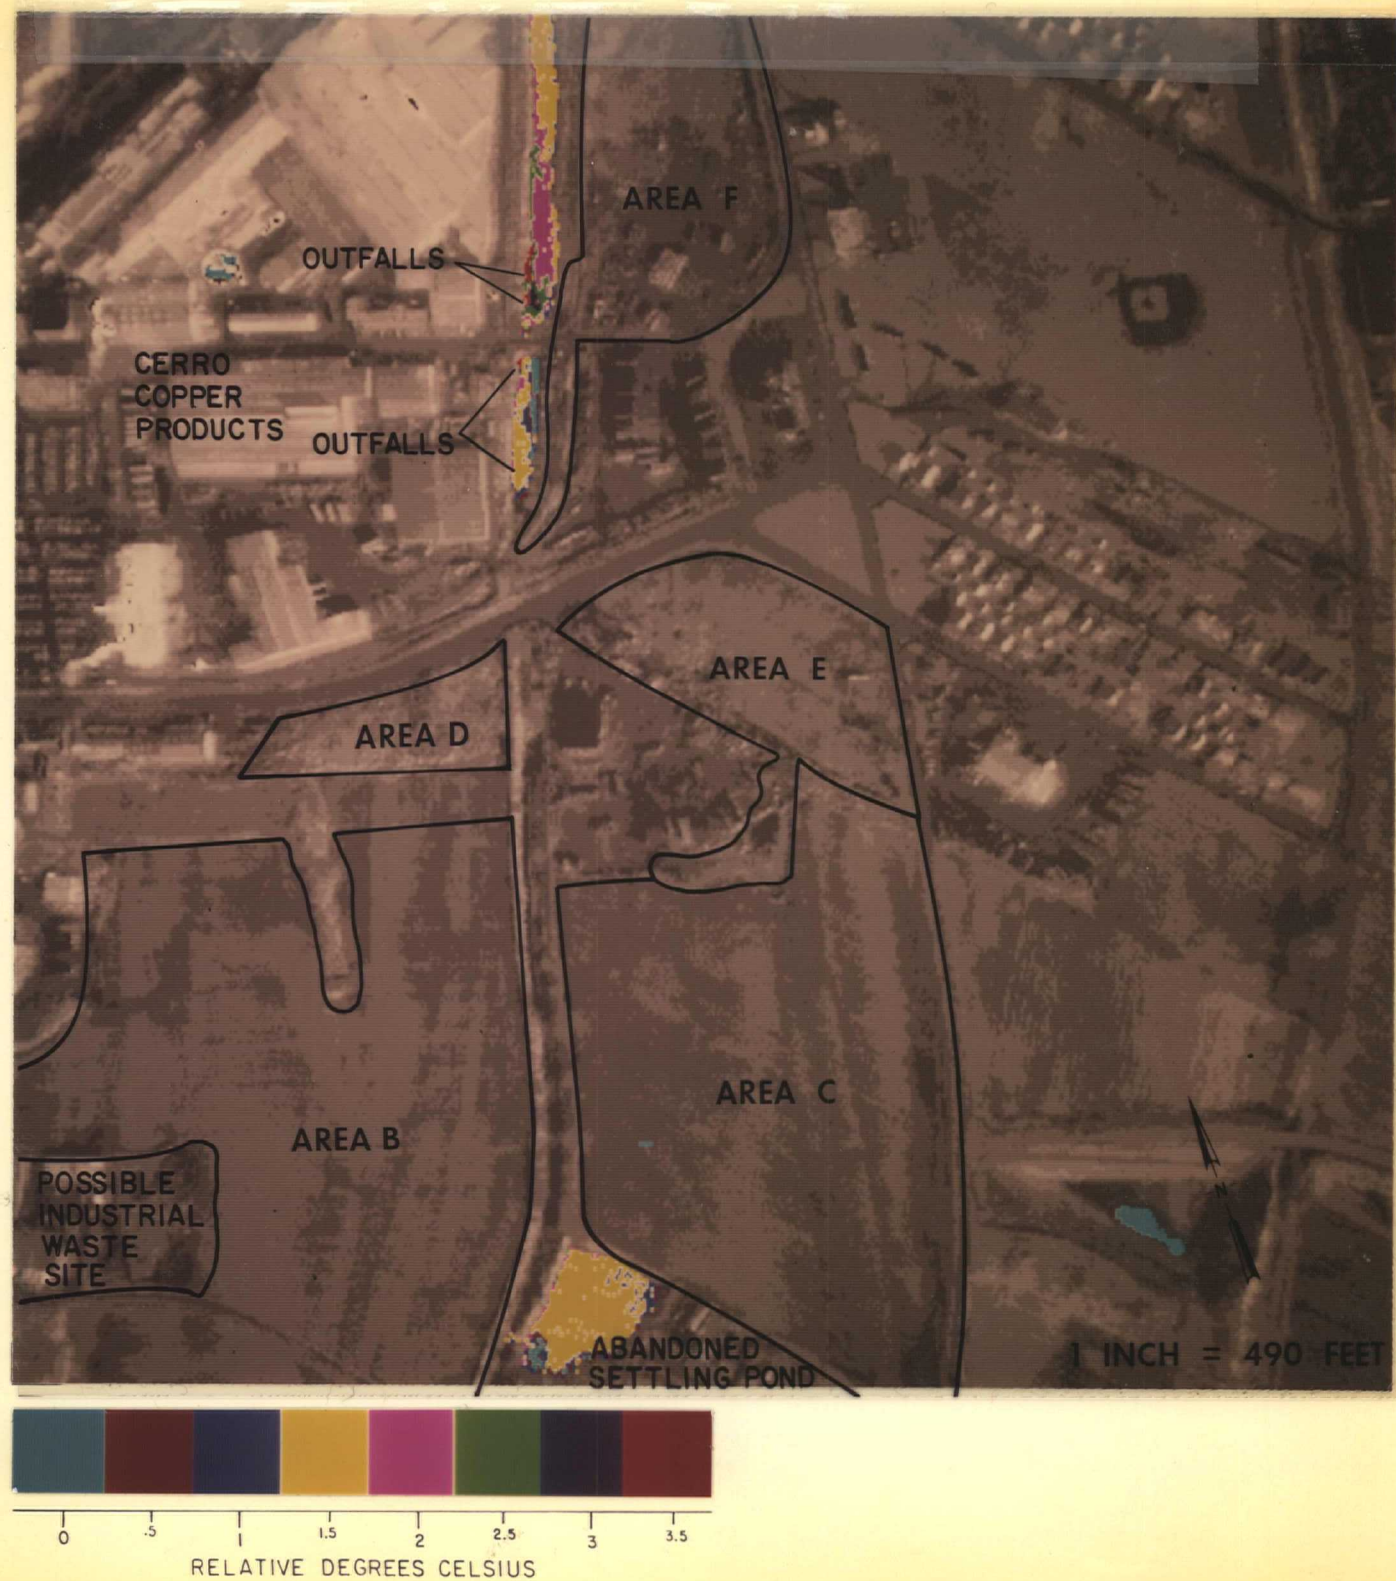
Multispectral data was acquired of the entire survey area; however, analysis of the data revealed no significant thermal influence over the land mass area. Therefore, only those areas immediately adjacent to the water body are included in this report.

The Dead Creek Lagoon displayed temperature variations of 3.5° Celsius. The water along the east bank, close to the lagoon bridge, was the coldest water temperature within the thermal map and was designated 0° Celsius (ambient). All other water within the scene was calibrated in 0.5° Celsius increments and related to this temperature.

The Cerro Copper Products plant displayed four discharges into the lagoon. The three northernmost discharges were operating at 3.5° Celsius above ambient and the south discharge was operating at 2.0° Celsius above ambient.

The temperature variation displayed within the abandoned settling pond, near the south edge of the image, is probably attributable to solar influence on the stagnant liquid.

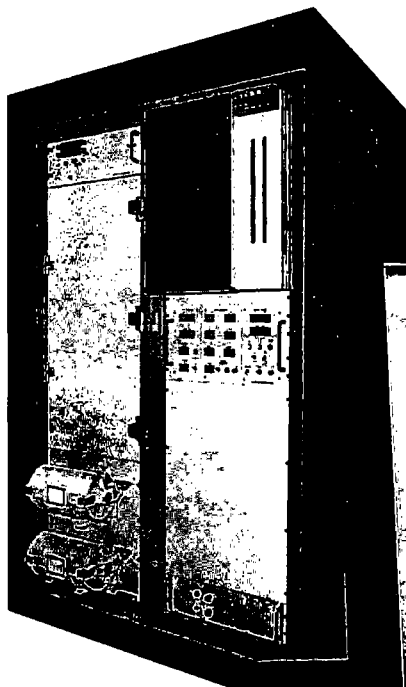
For thermal mapping applications, the scanner's internal, temperature calibration reference sources (blackbodies) are used along with surface temperature measurements to develop an accurate surface temperature map. Data processing is accomplished with the Data Analysis System (DAS) (see Attached Figure) consisting of a sensor tape playback unit, a high speed digital computer, an interactive color display system, and an off-line color film recorder.
